The State of the Verde River

A summary of five years of water quality data collection by the Arizona Water Sentinels (December 2006 to December 2011)

By Steve Pawlowski
Water Sentinels Program Coordinator
Grand Canyon Chapter of the Sierra Club
Revised May 2012

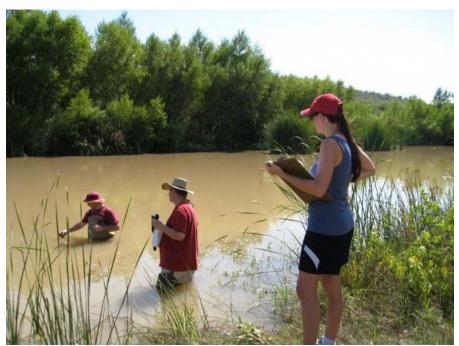
Figure 9. Arizona Water Sentinels sampling at Beasley Flat Photo credit: Sandy Bahr

Since December 2006, the Arizona Water Sentinels have implemented a volunteer water quality and flow monitoring program on the Verde River. Teams of volunteers have collected water samples, made field measurements of water quality parameters, and measured the flow of the river at six to eight sampling sites. A team of volunteers measures discharge (i.e., the flow) monthly at two sites on the upper Verde River: Above Verde Springs and Perkinsville. Three other teams of volunteers go to six sampling sites on the upper and middle Verde River to make field measurements of dissolved oxygen, pH, electrical conductivity, total dissolved solids, and

water temperature.⁶ They collect water samples from the Verde River for later laboratory analyses to determine the concentrations of *Escherichia coli (E. coli)* bacteria, total arsenic, total nitrogen, total phosphorus, and the suspended sediment concentration of the river.⁷ Arizona Water Sentinels have gone to the Verde River monitoring sites at least five times during each calendar year between December 2, 2006, and December 31, 2011.

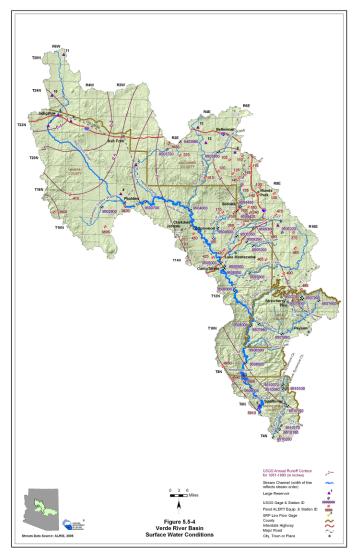
The Verde River watershed is located in central Arizona [See inset in Figure 13 below]. The Verde River watershed area is large, encompassing approximately 6,622 square miles or 4.2 million acres. As the inset below illustrates, the Verde River watershed is located entirely within the borders of the State of Arizona.

Figure 13. The Verde River watershed Source: Arizona Department of Water Resources Water Atlas

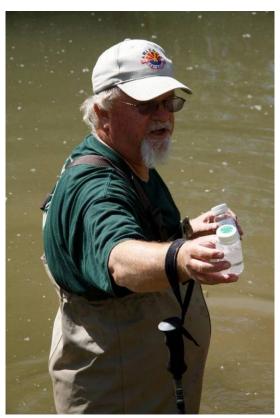
Figure 23. Water Sentinel collecting an *E. coli* bacteria sample Photo credit: Steve Pawlowski

Arizona Water Sentinels collect water samples from the Verde River for *Escherichia coli* (*E. coli*) bacteria analyses. *E. coli* bacteria are a widely accepted indicator organism of fecal contamination of water. Water Sentinels have collected water quality data for *E. coli* bacteria since the inception of our volunteer monitoring program on the Verde River. The dataset includes 194 *E. coli* sample results from seven sampling sites on the Verde River from samples collected between December 2, 2006, and December 10, 2011.

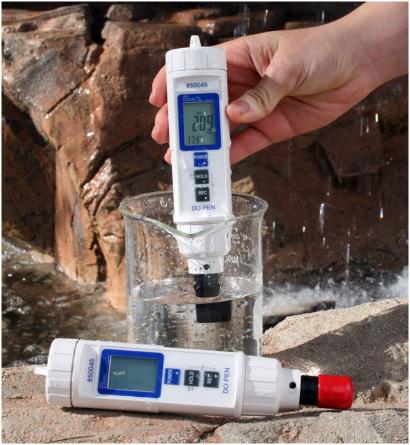
The Arizona Water Sentinels use a Sper Scientific DO pen meter to measure DO concentrations.

Figure 27. A Sper Scientific dissolved oxygen pen meter Source: Sper Scientific web site.

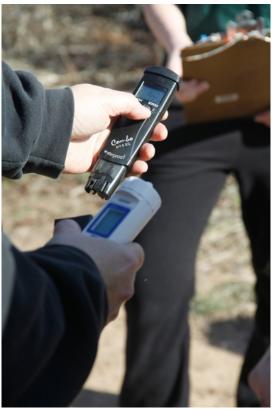
Figure 29. The Hanna combo tester Photo credit: Mark Coryell
