Upper Verde River Habitat Analysis Executive Summary 2020 - 2023

Prepared by the U.S. Rocky Mountain Research Station and Northern Arizona University in cooperation with the Prescott National Forest and the U.S. Bureau of Reclamation.

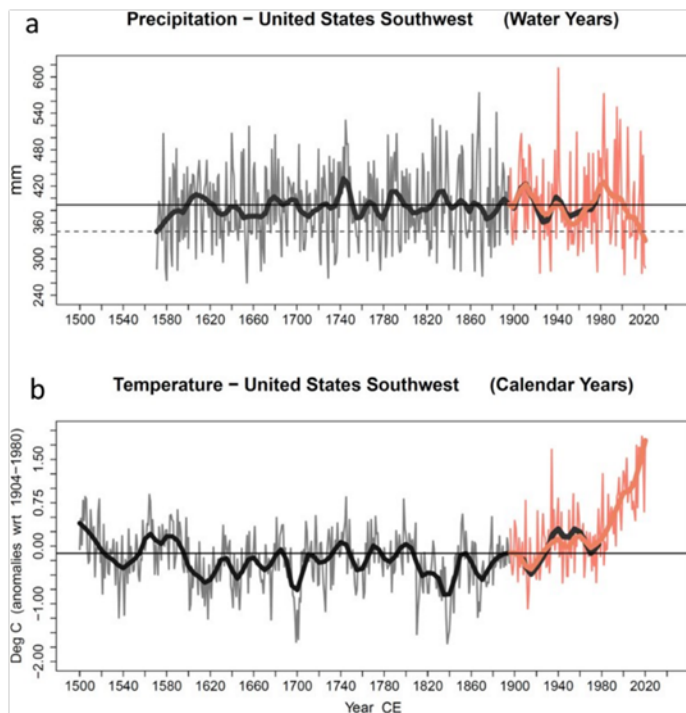
Figure 3: Average precipitation and temperature within the southwestern United States over the last 500 years (Wahl et al. 2022).

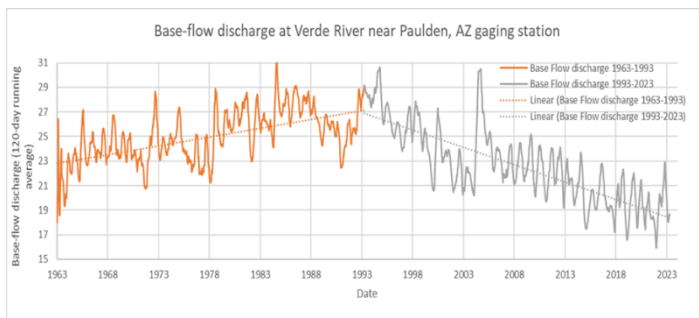
Figure 4 Baseflow decline in the Upper Verde River since 1993. Data taken from the USGS stream gauge at Paulden, Arizona. Credit Joel Unema, USGS URL: <https://waterdata.usgs.gov/nwis/monthly?>

Daily discharge of the UVR between Paulden, AZ and Sycamore Canyon has decreased over the last thirteen years. Specifically, the US Geological Survey (USGS) gauge data indicates that the mean daily discharge of the UVR at the Paulden, AZ gauge decreased 39% from 1.2 m³/s (44 ft³/s) between 1963 and 2008 to an average of 0.8 m³/s (27 ft³/s) between 2006 and 2021.

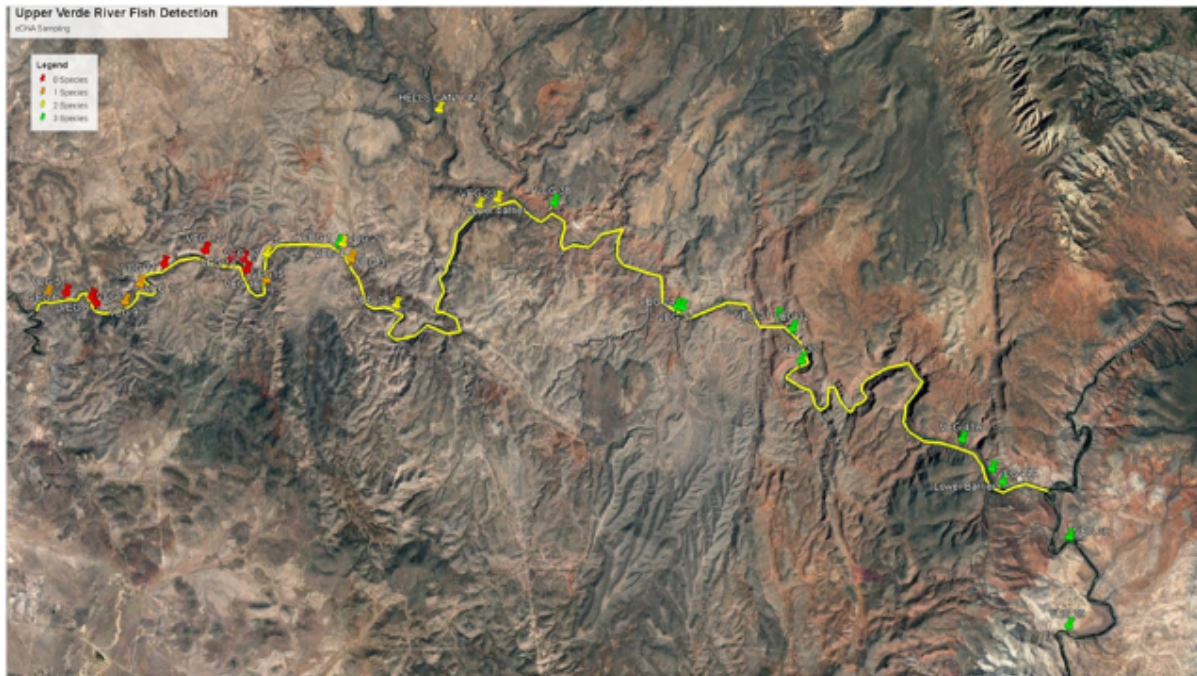
Figure 10: Locations sampled with eDNA species detection methodology. Of the native species sampled, Red pins = no native species present, orange pins = 1 species present, yellow pins = 2 species present, and green pins = 3 species present.

In November of 2021 and 2022 a total of twenty-nine sites located along the entirety of the study area were sampled using eDNA sampling methods developed RMRS and the National Genomics Center for Wildlife and Conservation (Carim et. al 2016). The method requires 5 liters of stream water to be drawn through a 1.5- μ m-pore, fiberglass filter which is then packaged and sent to the lab for DNA analysis. Specific sampling locations were located within the 40-meter reach length of a long-term monitoring site in well-mixed water, near the center of the channel. Sampling sites were co-located with long-term, quantitative sampling sites using electro fishing methods established by the USFS in the 1990s.

Sample analysis was conducted to determine the presence/absence of four native species including Sonora sucker, desert sucker, spikedace and roundtail chub. Two native species still present in the river, the longfin dace and speckled dace were not screened because the DNA assays for these two species are still in development. However, once developed, samples can be re-run to detect the presence of these species.

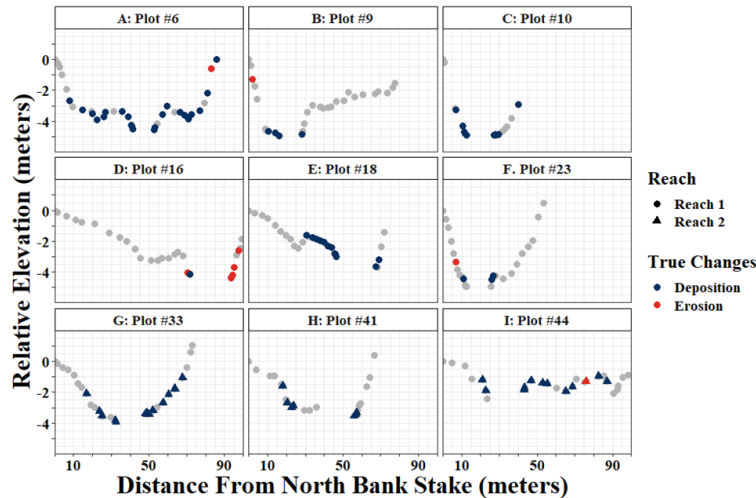
Figure 11: Lidar-derived change detection results. Channel cross-sections showing where the significant changes have occurred, colored by whether they are deposition or erosion.

Topographic data from the 2009 USFS survey were compared to the 2021-2022 lidar data for geomorphic change detection which indicated that there were statistically significant changes at all nine plots available for comparison (Table 4). Other than Plot #16, more deposition than erosion occurred at all plots, and most of the changes, whether deposition or erosion, ranged between 0cm and 50cm. The deposition largely occurred in the floodplain nearest the channels. The notable exception is again Plot #16, which has eroded on the south bank further away from

the channel (Figure 11). Importantly, the results were consistent with the change detection results from the comparison between the 2009 and 2021 USFS survey data.

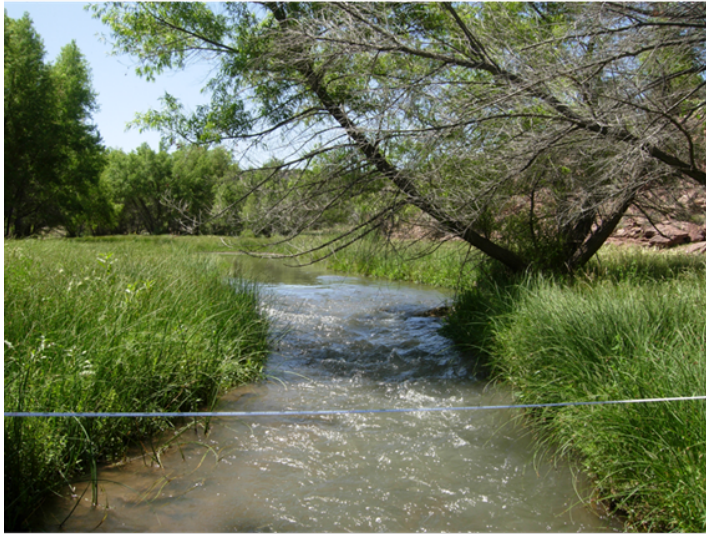
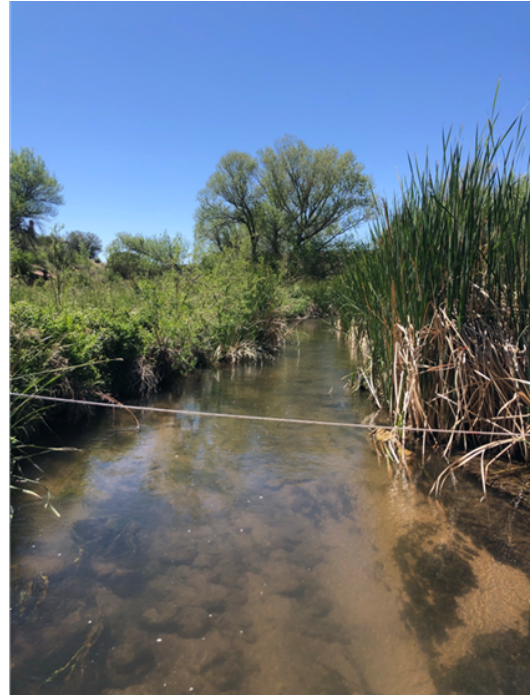
Figure 12: Photographs from 2009 (Panel A) and 2021 (Panel B) at Plot #1 illustrating the changes in riffle habitat and cattail density over the study period.
